## **BUILDING ENVELOPE CONDITION ASSESSMENT**

### **KYLE CENTER**

125 KYLE STREET  
PORT MOODY, BC

JRS Project No. VR11262A

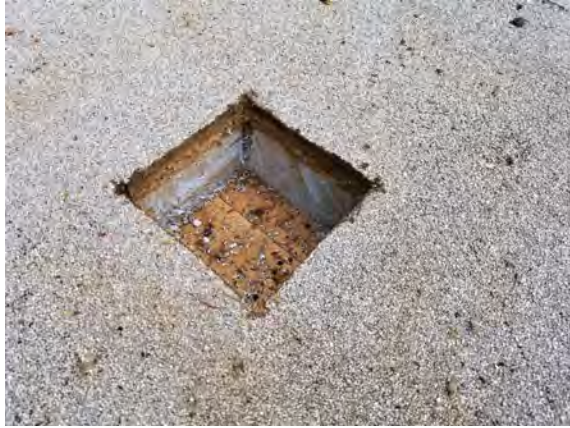
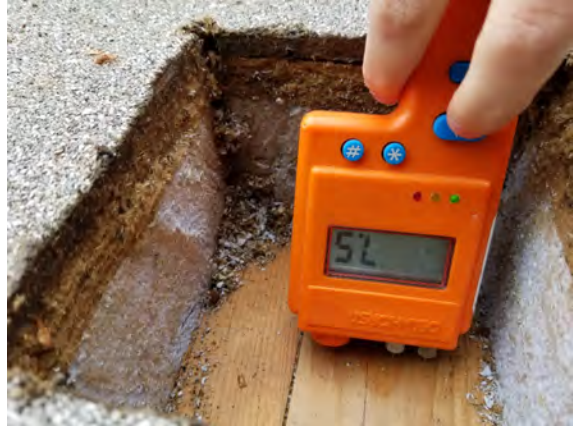
<b>Location:</b>	Roof E – (south-east corner)	<b>EO 1</b>
<b>Detail:</b>	2-ply SBS roof, field of roof	
<b>Moisture Content:</b>	7.5%

Assembly	Condition
<ul style="list-style-type: none"> <li>• 2-Ply SBS-modified bitumen membrane</li> <li>• 2 layers 5/8" fibreboard, adhered</li> <li>• 2 layers 1½" extruded polystyrene insulation</li> <li>• Tongue and groove plank decking</li> </ul>	<ul style="list-style-type: none"> <li>• Membrane was well-adhered to fireboard.</li> <li>• Fibreboard and insulation appeared dry.</li> <li>• Deck is in good condition.</li> </ul>
Comments	
<ul style="list-style-type: none"> <li>• Cut test was prepared in area where roof has been previously replaced.</li> <li>• No moisture detected within assembly</li> </ul>

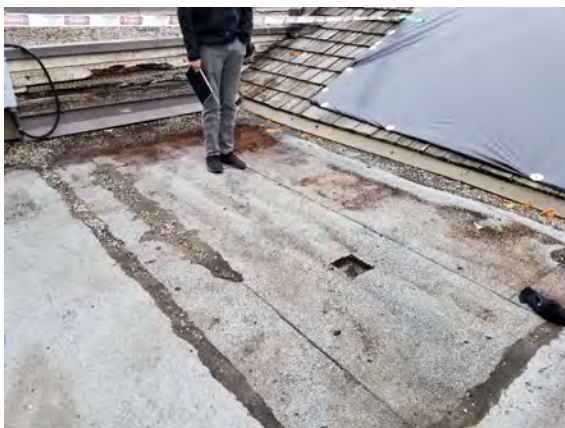
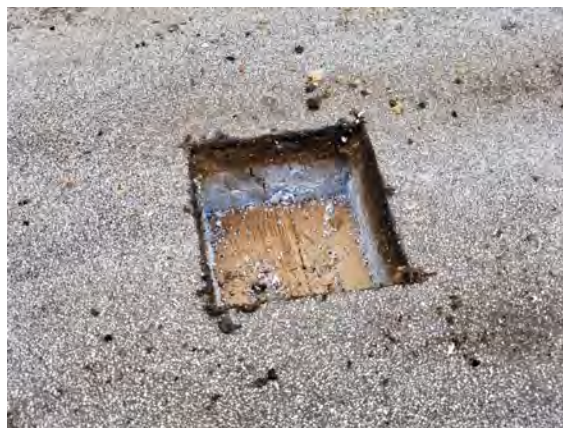
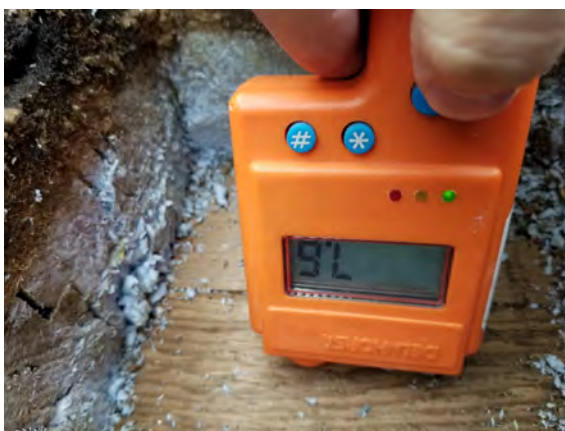
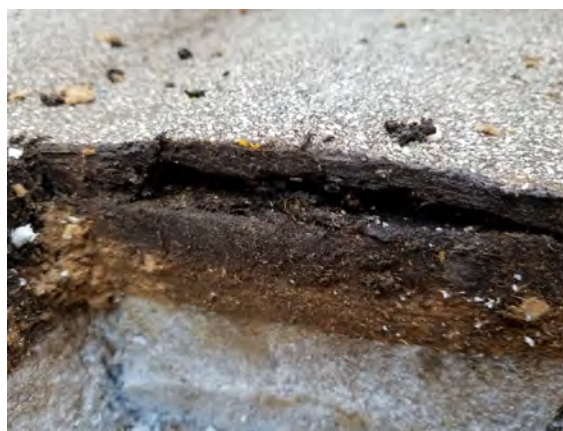
**EO 2**

**Location:** Roof E – (north-east from rooftop mechanical)

- 2-Ply SBS-modified bitumen membrane
- 2 layers 5/8" fibreboard, adhered
- 2 layers 1 1/2" extruded polystyrene insulation
- Tongue and groove plank decking

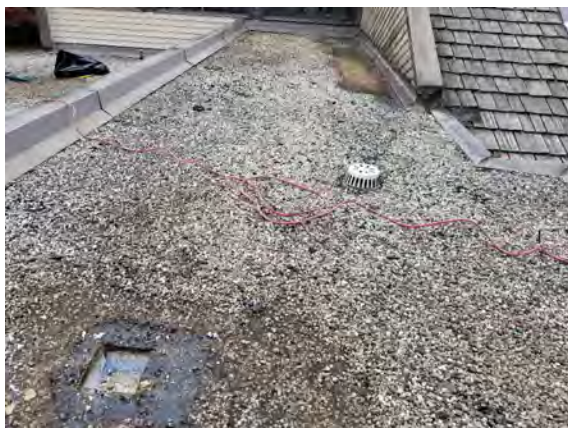
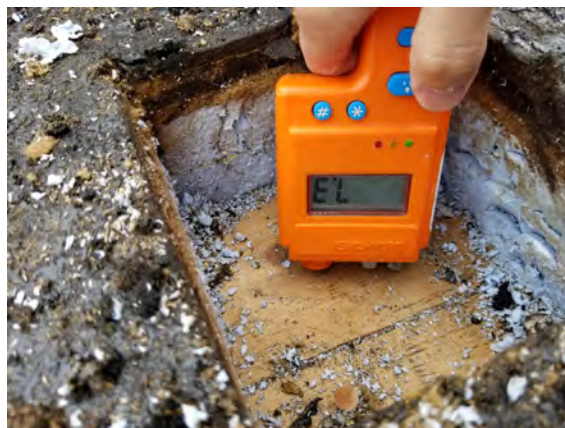
# EO 3

Assembly	Condition
<ul style="list-style-type: none"> <li>• 4-ply BUR (asphalt and felt)</li> <li>• 2 layers 5/8" fibreboard, adhered.</li> <li>• 2 layers 1 1/2" extruded polystyrene insulation</li> <li>• Tongue and groove plank decking</li> </ul>	<ul style="list-style-type: none"> <li>• BUR was well-adhered to fireboard.</li> <li>• Fibreboard and insulation appeared dry.</li> <li>• Deck is in good condition.</li> </ul>
Comments	
<ul style="list-style-type: none"> <li>• Cut test was prepared in area where original BUR is still in place.</li> <li>• No moisture detected within assembly</li> </ul>

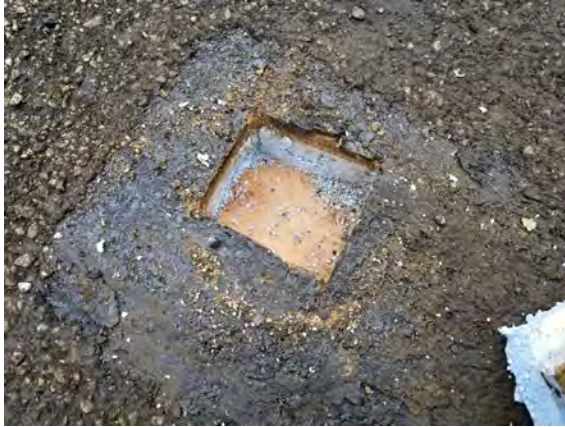
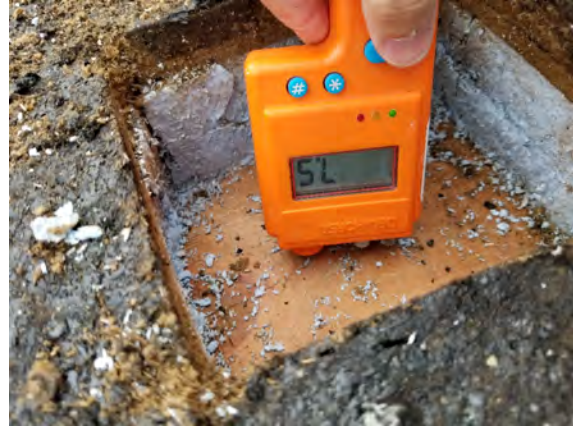
# EO 4

Assembly	Condition
<ul style="list-style-type: none"> <li>• 4-ply BUR (asphalt and felt)</li> <li>• 2 layers 5/8" fibreboard, adhered.</li> <li>• 2 layers 1 1/2" extruded polystyrene insulation</li> <li>• Tongue and groove plank decking</li> </ul>	<ul style="list-style-type: none"> <li>• BUR was well-adhered to fireboard.</li> <li>• Fibreboard and insulation appeared dry.</li> <li>• Deck is in good condition.</li> </ul>
Comments	
<ul style="list-style-type: none"> <li>• Cut test was prepared in area where original BUR is still in place.</li> <li>• No moisture detected within assembly</li> </ul>

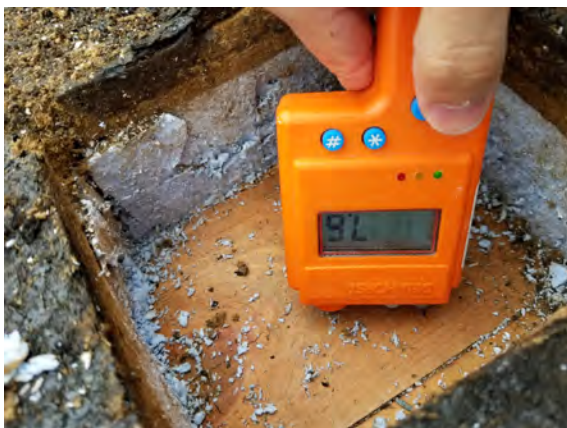
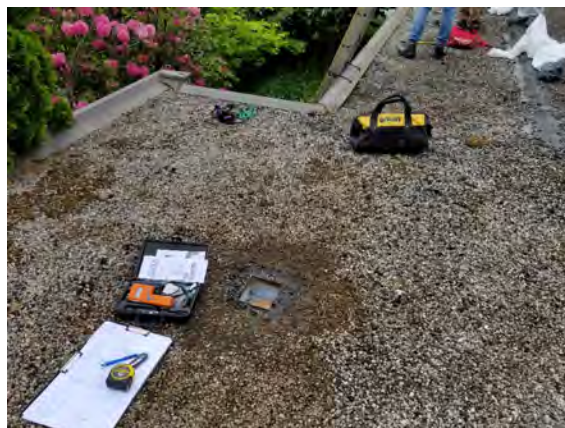
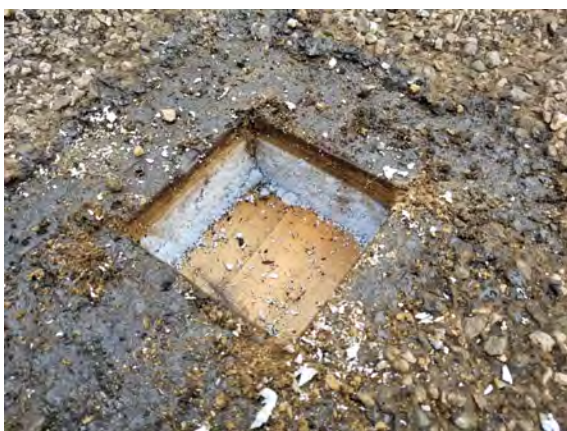
**EO 5**

**Location:** Roof A – (north-west)  
**Detail:** Asphalt (build-up-roof), field of roof  
**Moisture Content:** 7.6%

- 4-ply BUR (asphalt and felt)
- 2 layers 5/8" fibreboard, adhered.
- 2 layers 1 1/2" extruded polystyrene insulation
- Tongue and groove plank decking

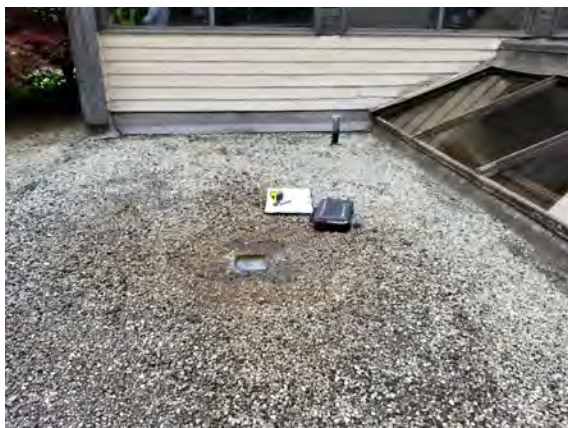
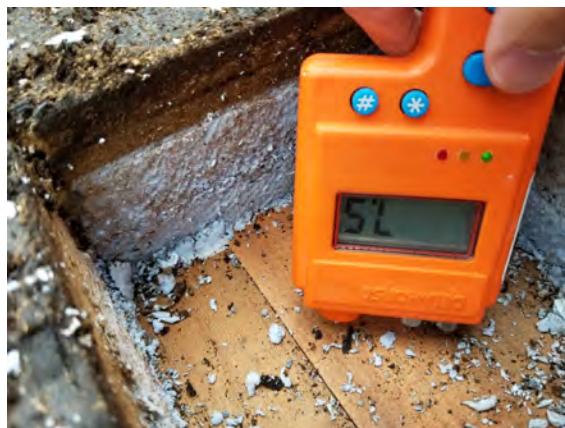
# EO 6

Assembly	Condition
<ul style="list-style-type: none"> <li>• 4-ply BUR (asphalt and felt)</li> <li>• 2 layers 5/8" fibreboard, adhered.</li> <li>• 2 layers 1 1/2" extruded polystyrene insulation</li> <li>• Tongue and groove plank decking</li> </ul>	<ul style="list-style-type: none"> <li>• BUR was well-adhered to fireboard.</li> <li>• Fibreboard and insulation appeared dry.</li> <li>• Deck is in good condition.</li> </ul>
Comments	
<ul style="list-style-type: none"> <li>• Cut test was prepared in area where original BUR is still in place.</li> <li>• No moisture detected within assembly</li> </ul>

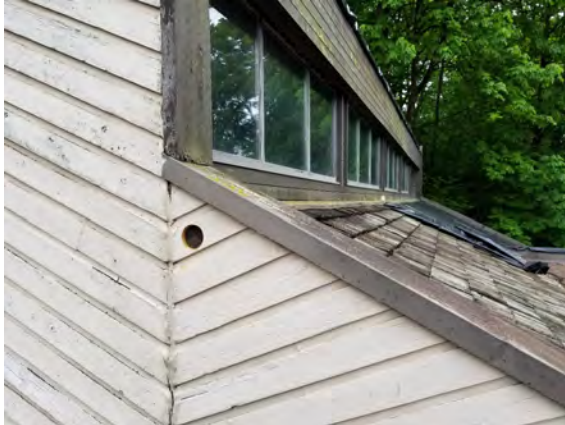
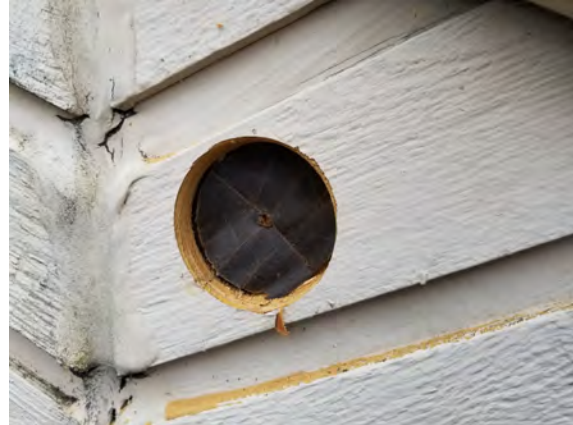
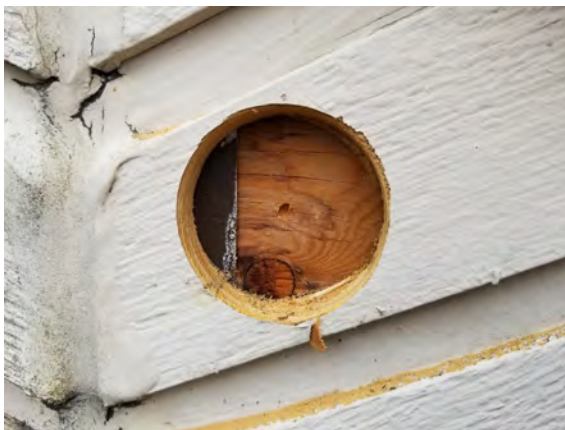
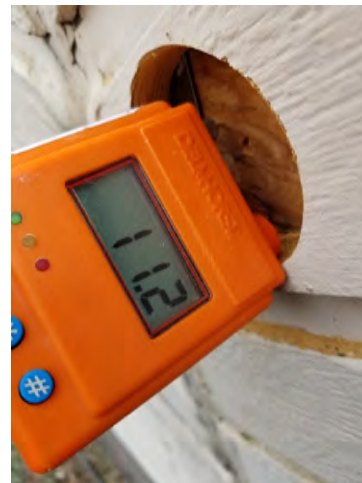
<b>Location:</b>	East-facing wall on roof	<b>EO 7</b>
<b>Detail:</b>	Cedar cladding, at interface with roof slope	
<b>Moisture Content:</b>	11.2%

Assembly	Condition
<ul style="list-style-type: none"> <li>Channel cedar siding</li> <li>Building Paper</li> <li>1/2" plywood</li> <li>2"x6" wood framing at 16" o/c</li> <li>6" batt insulation between studs</li> <li>6 mil polyethylene vapour barrier</li> <li>Interior finishes</li> </ul>	<ul style="list-style-type: none"> <li>Cladding in fair condition at this location.</li> <li>Nearby sealant was in poor condition.</li> <li>Building paper was in generally good condition at the time of our review.</li> <li>Some staining visible on plywood sheathing.</li> </ul>
Comments	
<ul style="list-style-type: none"> <li>Stains on sheathing indicate prior water ingress behind building paper.</li> <li>Assembly was dry at the time of review.</li> </ul>

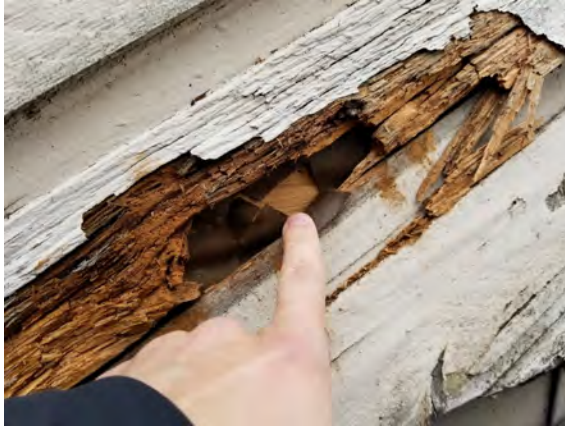
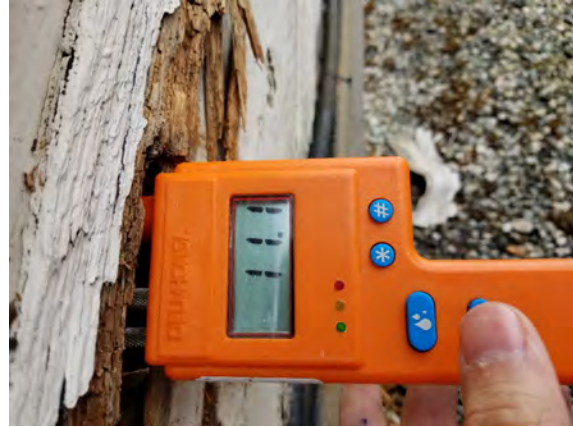
<b>Location:</b>	East-facing wall on roof	<b>EO 8</b>
<b>Detail:</b>	Cedar cladding, base of wall detail	
<b>Moisture Content:</b>	11.1%

Assembly	Condition
<ul style="list-style-type: none"> <li>• Channel cedar siding</li> <li>• Building Paper</li> <li>• 1/2" plywood</li> <li>• 2"x6" wood framing at 16" o/c</li> <li>• 6" batt insulation between studs</li> <li>• 6 mil polyethylene vapour barrier</li> <li>• Interior finishes</li> </ul>	<ul style="list-style-type: none"> <li>• Significantly deteriorated cladding.</li> <li>• Missing and torn building paper</li> <li>• Sheathing appeared to be in good condition and was dry at the time of our review.</li> </ul>
Comments	
<ul style="list-style-type: none"> <li>• Significant damage to cladding.</li> <li>• Assembly was dry at the time of review.</li> </ul>

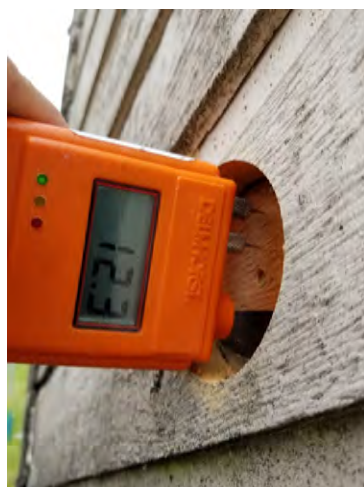
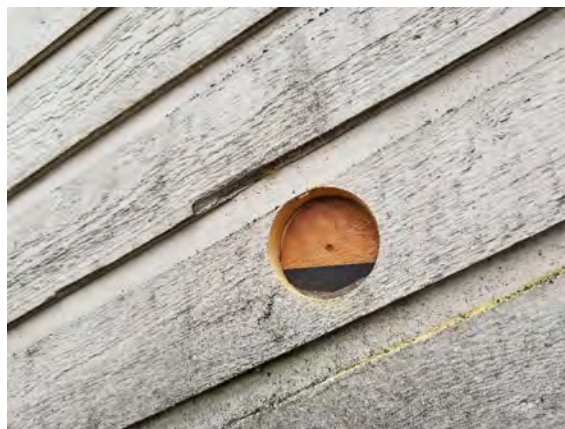
<b>Location:</b>	North-facing wall on roof	<b>EO 9</b>
<b>Detail:</b>	Cedar cladding	
<b>Moisture Content:</b>	12.3%

Assembly	Condition
<ul style="list-style-type: none"> <li>• Channel cedar siding</li> <li>• Building Paper</li> <li>• 1/2" plywood</li> <li>• 2"x6" wood framing at 16" o/c</li> <li>• 6" batt insulation between studs</li> <li>• 6 mil polyethylene vapour barrier</li> <li>• Interior finishes</li> </ul>	<ul style="list-style-type: none"> <li>• Cladding in fair condition at this location.</li> <li>• Building paper was in generally good condition at the time of our review.</li> <li>• Sheathing appeared dry at the time of our review.</li> </ul>
Comments	
<ul style="list-style-type: none"> <li>• Assembly was dry at the time of our review.</li> </ul>

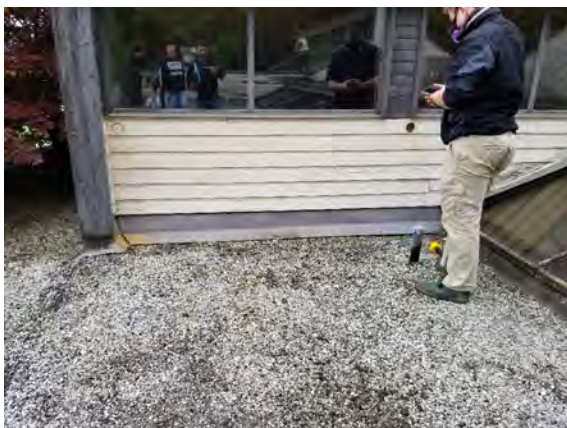
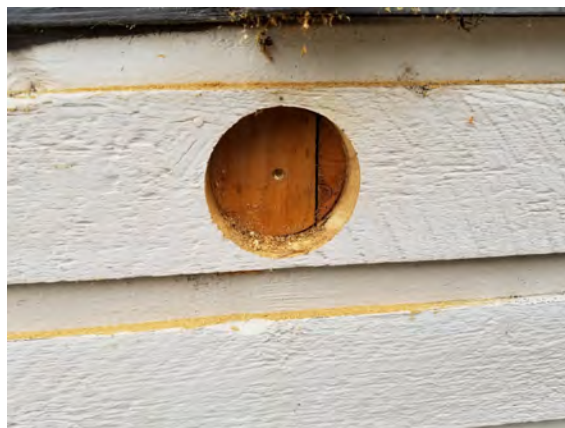
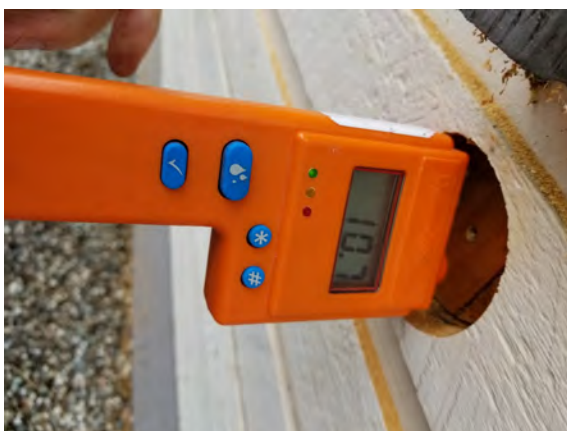
**EO 10**

**Location:** West-facing wall on roof  
**Detail:** Cedar cladding, below window sill  
**Moisture Content:** 10.7%

- Channel cedar siding
- Building Paper
- 1/2" plywood
- 2"x6" wood framing at 16" o/c
- 6" batt insulation between studs
- 6 mil polyethylene vapour barrier
- Interior finishes

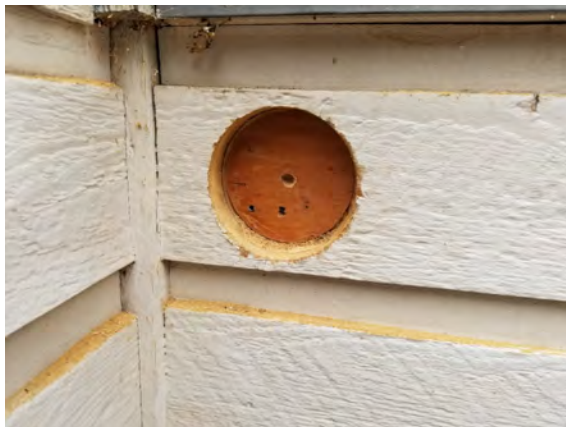
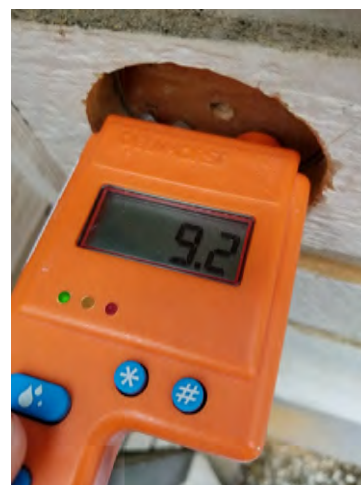
<b>Location:</b>	West-facing wall on roof	<b>EO 11</b>
<b>Detail:</b>	Cedar cladding, below window sill	
<b>Moisture Content:</b>	9.2%

Assembly	Condition
<ul style="list-style-type: none"> <li>Channel cedar siding</li> <li>Building Paper</li> <li>1/2" plywood</li> <li>2"x6" wood framing at 16" o/c</li> <li>6" batt insulation between studs</li> <li>6 mil polyethylene vapour barrier</li> <li>Interior finishes</li> </ul>	<ul style="list-style-type: none"> <li>Cladding in fair condition at this location.</li> <li>Building paper was in generally good condition at the time of our review.</li> <li>Sheathing appeared dry at the time of our review.</li> </ul>
Comments	
<ul style="list-style-type: none"> <li>Assembly was dry at the time of our review.</li> </ul>

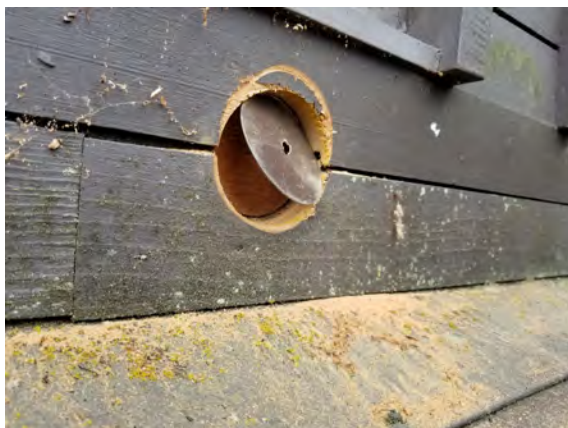
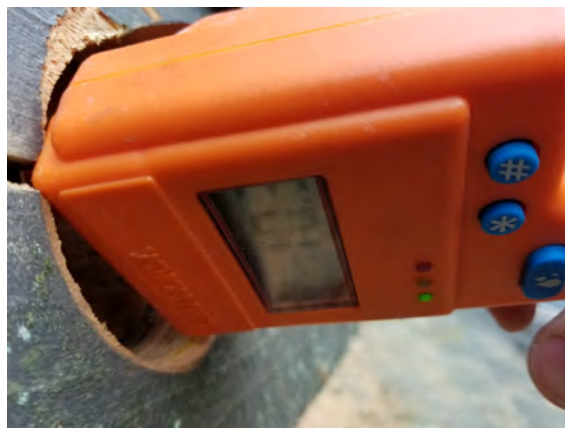
<b>Location:</b>	North-facing wall on roof	<b>EO 13</b>
<b>Detail:</b>	Cedar cladding, below window sill	
<b>Moisture Content:</b>	10.3%

Assembly	Condition
<ul style="list-style-type: none"> <li>• Channel cedar siding</li> <li>• Building Paper</li> <li>• 1/2" plywood</li> <li>• 2"x6" wood framing at 16" o/c</li> <li>• 6" batt insulation between studs</li> <li>• 6 mil polyethylene vapour barrier</li> <li>• Interior finishes</li> </ul>	<ul style="list-style-type: none"> <li>• Cladding in fair condition at this location.</li> <li>• Building paper was in generally good condition at the time of our review.</li> <li>• Sheathing appeared dry at the time of our review.</li> </ul>
Comments	
<ul style="list-style-type: none"> <li>• Assembly was dry at the time of our review.</li> </ul>

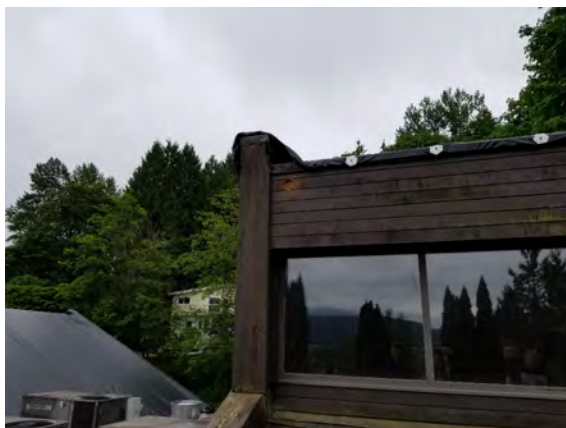
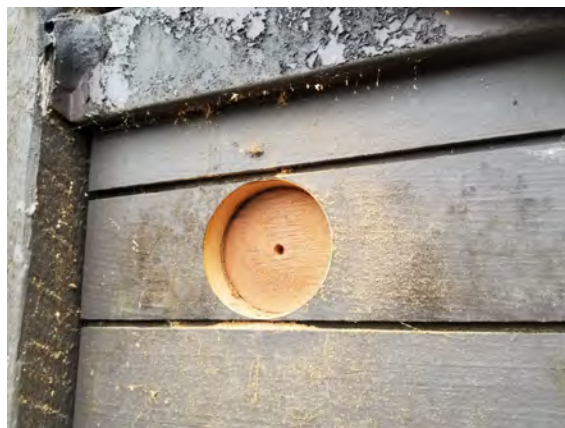
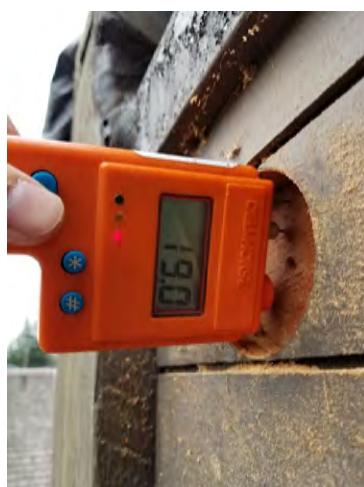
<b>Location:</b>	North-facing wall on roof	<b>EO 14</b>
<b>Detail:</b>	Cedar cladding, top of wall, below parapet cap flashing	
<b>Moisture Content:</b>	19.0%

Assembly	Condition
<ul style="list-style-type: none"> <li>Channel cedar siding</li> <li>Building Paper</li> <li>1/2" plywood</li> <li>2"x6" wood framing at 16" o/c</li> <li>6" batt insulation between studs</li> <li>6 mil polyethylene vapour barrier</li> <li>Interior finishes</li> </ul>	<ul style="list-style-type: none"> <li>Cladding in poor condition at this location.</li> <li>Building paper was in generally good condition at the time of our review.</li> <li>Moisture observed behind building paper.</li> <li>High moisture content in sheathing.</li> </ul>
Comments	
<ul style="list-style-type: none"> <li>Moisture noted behind building paper.</li> <li>Poor sealant and separated cladding noted at roof parapet above this location.</li> </ul>

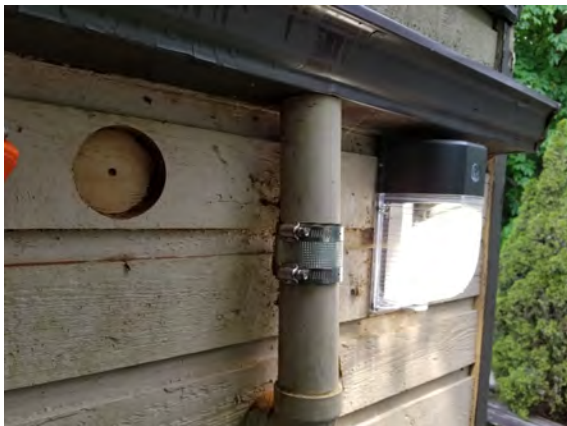
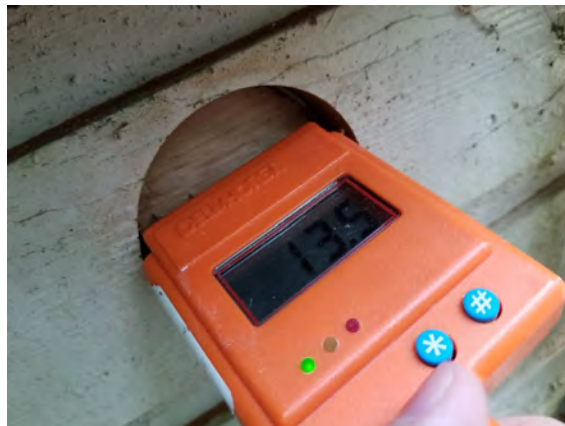
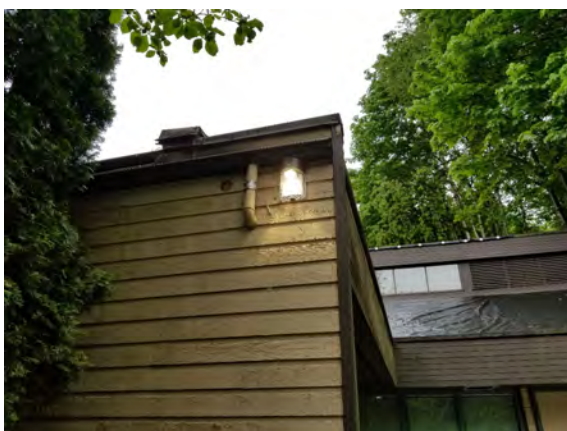
**EO 15**

**Location:** North elevation, west corner  
**Detail:** Cedar cladding, below skylight sill  
**Moisture Content:** 13.5%

- Channel cedar siding
- Building Paper
- 1/2" plywood
- 2"x6" wood framing at 16" o/c
- 6" batt insulation between studs
- 6 mil polyethylene vapour barrier
- Interior finishes

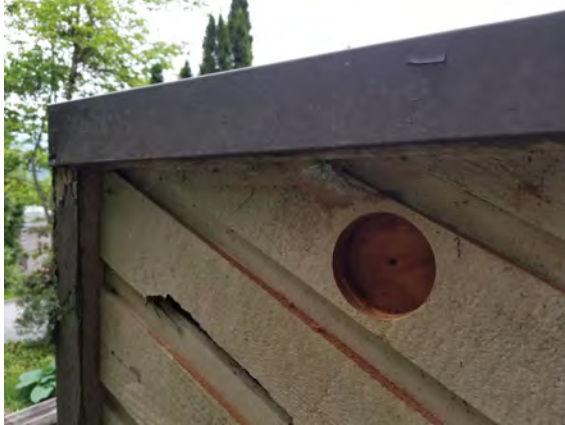
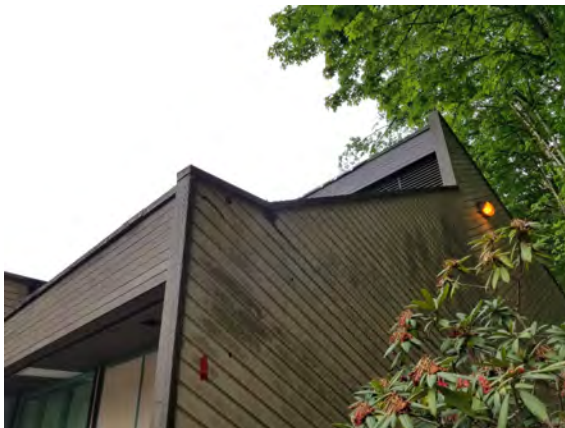
# EO 16

Assembly	Condition
<ul style="list-style-type: none"> <li>Channel cedar siding</li> <li>Building Paper</li> <li>1/2" plywood</li> <li>2"x6" wood framing at 16" o/c</li> <li>6" batt insulation between studs</li> <li>6 mil polyethylene vapour barrier</li> <li>Interior finishes</li> </ul>	<ul style="list-style-type: none"> <li>Cladding in poor condition at this location.</li> <li>Building paper was in generally good condition at the time of our review.</li> <li>Sheathing appeared dry at the time of our review.</li> </ul>
Comments	
<ul style="list-style-type: none"> <li>Assembly was dry at the time of our review.</li> </ul>

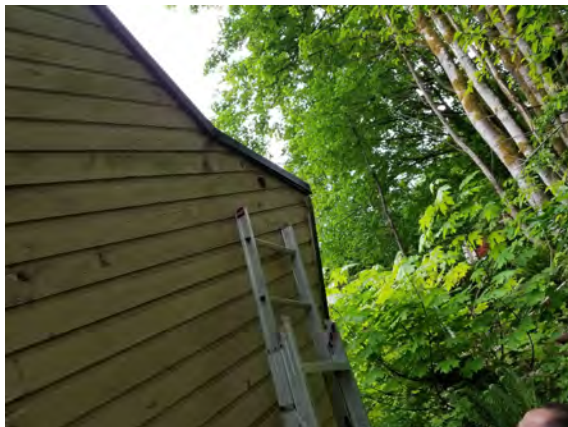
<b>Location:</b>	West-elevation, south corner	<b>EO 17</b>
<b>Detail:</b>	Cedar cladding, below sloped roof area	
<b>Moisture Content:</b>	14.4%

Assembly	Condition
<ul style="list-style-type: none"> <li>Channel cedar siding</li> <li>Building Paper</li> <li>1/2" plywood</li> <li>2"x6" wood framing at 16" o/c</li> <li>6" batt insulation between studs</li> <li>6 mil polyethylene vapour barrier</li> <li>Interior finishes</li> </ul>	<ul style="list-style-type: none"> <li>Cladding in poor condition at this location.</li> <li>Building paper was in generally good condition at the time of our review.</li> <li>Staining visible on sheathing.</li> </ul>
Comments	
<ul style="list-style-type: none"> <li>Evidence of past moisture ingress behind building paper at this location.</li> </ul>

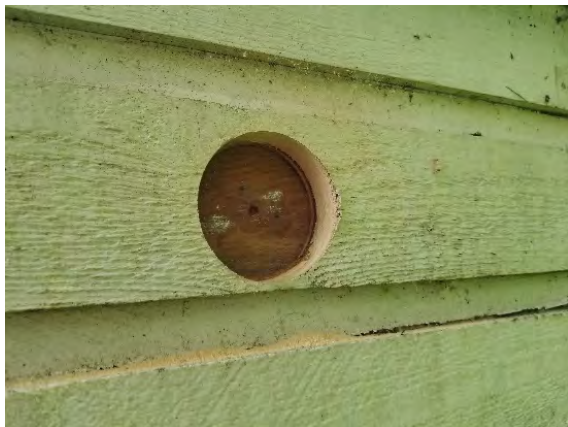
<b>Location:</b>	West-elevation, south corner	<b>EO 18</b>
<b>Detail:</b>	Cedar cladding, below parapet flashing.	
<b>Moisture Content:</b>	14.1%

Assembly	Condition
<ul style="list-style-type: none"> <li>Channel cedar siding</li> <li>Building Paper</li> <li>1/2" plywood</li> <li>2"x6" wood framing at 16" o/c</li> <li>6" batt insulation between studs</li> <li>6 mil polyethylene vapour barrier</li> <li>Interior finishes</li> </ul>	<ul style="list-style-type: none"> <li>Cladding in fair condition at this location.</li> <li>Building paper was in generally good condition at the time of our review.</li> <li>Staining visible on sheathing.</li> </ul>
Comments	
<ul style="list-style-type: none"> <li>Evidence of past moisture ingress behind building paper at this location.</li> </ul>

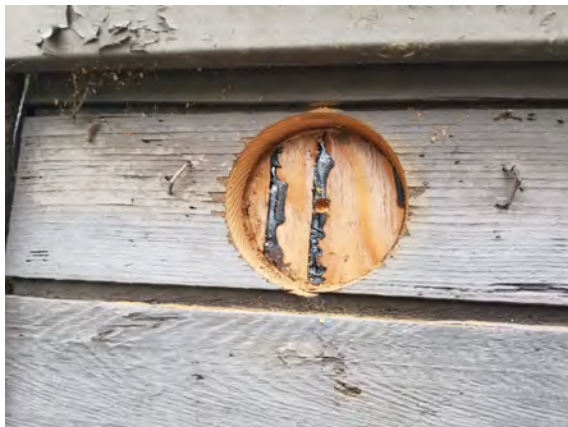
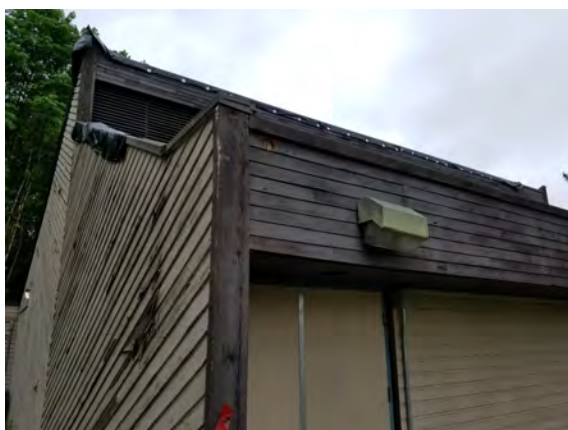
**EO 20**

- Channel cedar siding
- Building Paper
- 1/2" plywood
- 2"x6" wood framing at 16" o/c
- 6" batt insulation between studs
- 6 mil polyethylene vapour barrier
- Interior finishes

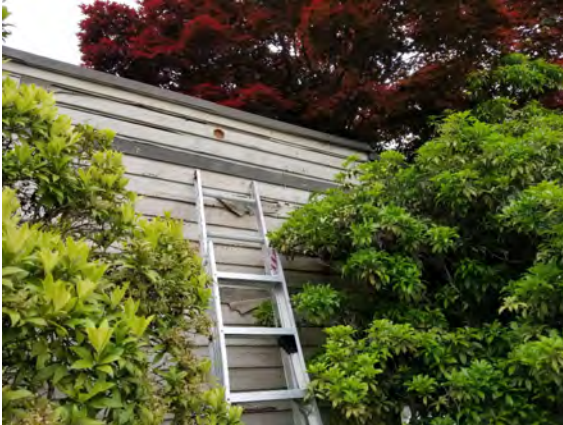
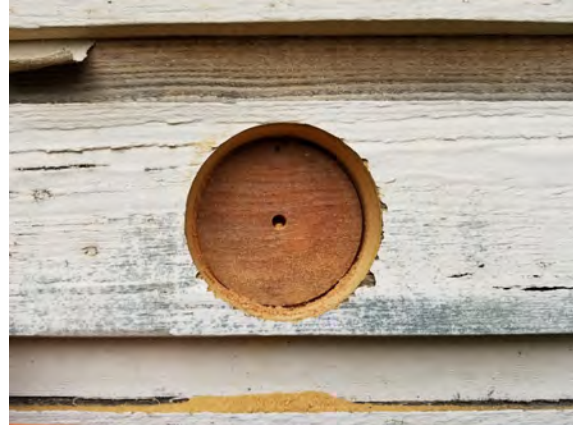
EO 21

Assembly	Condition
<ul style="list-style-type: none"> <li>Channel cedar siding</li> <li>Building Paper</li> <li>1/2" plywood</li> <li>2"x6" wood framing at 16" o/c</li> <li>6" batt insulation between studs</li> <li>6 mil polyethylene vapour barrier</li> <li>Interior finishes</li> </ul>	<ul style="list-style-type: none"> <li>Cladding in poor condition at this location.</li> <li>Building paper was in generally fair condition at the time of our review.</li> <li>Sheathing appeared dry at the time of our review.</li> </ul>
Comments	
<ul style="list-style-type: none"> <li>Assembly was dry at the time of our review.</li> </ul>

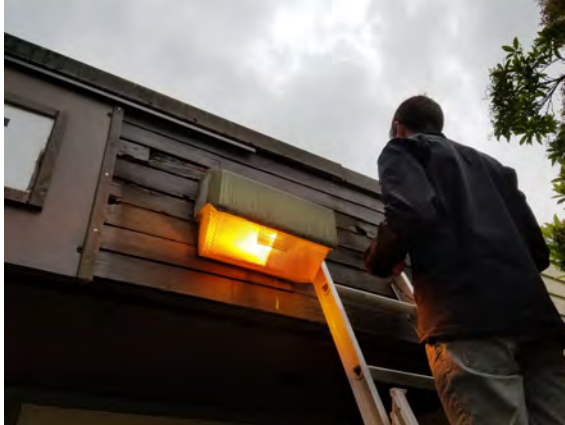
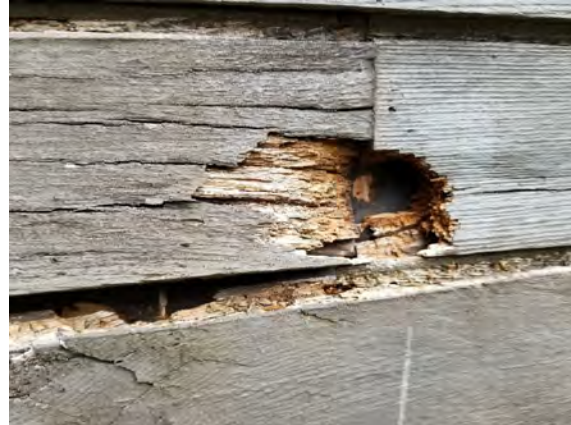
# EO 22

<b>Location:</b>	East-elevation, at signage
<b>Detail:</b>	Cedar cladding, near light penetration
<b>Moisture Content:</b>	Not measured at this location

Assembly	Condition
<ul style="list-style-type: none"> <li>• Channel cedar siding</li> <li>• Building Paper</li> <li>• 1/2" plywood</li> <li>• 2"x6" wood framing at 16" o/c</li> <li>• 6" batt insulation between studs</li> <li>• 6 mil polyethylene vapour barrier</li> <li>• Interior finishes</li> </ul>	<ul style="list-style-type: none"> <li>• Cladding significantly deteriorated at this location.</li> <li>• Building paper was in generally fair condition at the time of our review.</li> </ul>
Comments	
<ul style="list-style-type: none"> <li>• Assembly was dry at the time of our review.</li> </ul>

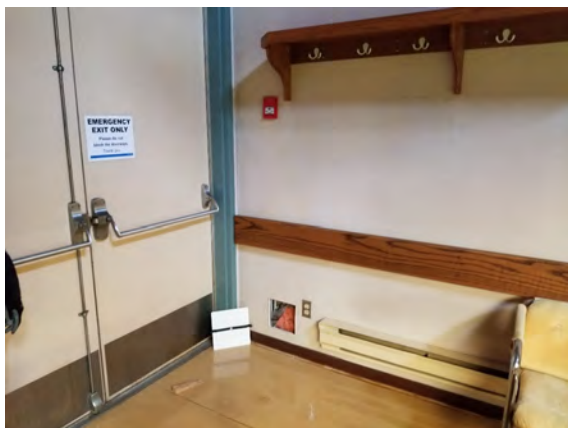
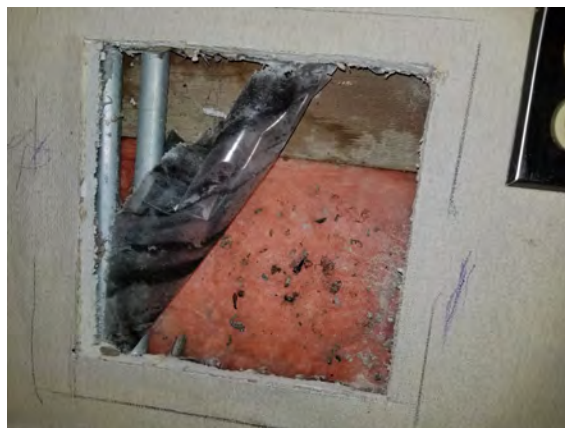
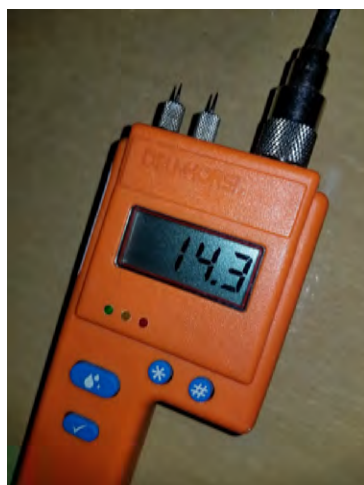
IO 1

**Location:** Billiards Room, west elevation (See Appendix C)

- Channel cedar siding
- Building Paper
- 1/2" plywood
- 2"x6" wood framing at 16" o/c
- 6" batt insulation between studs
- 6 mil polyethylene vapour barrier
- Interior finishes

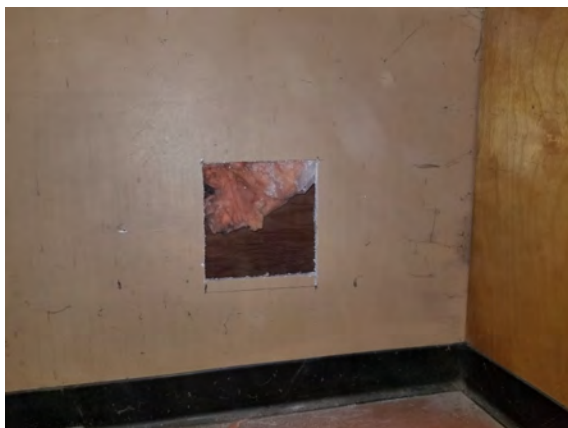
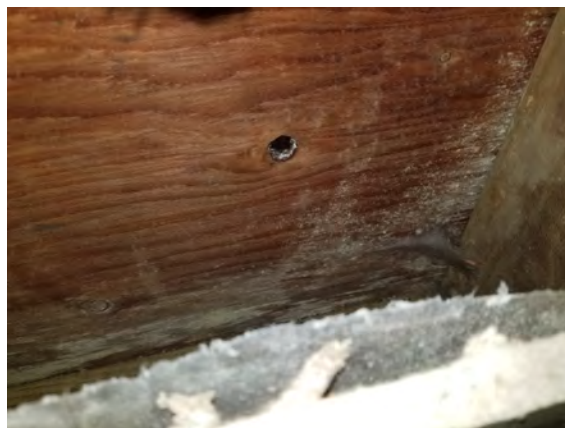
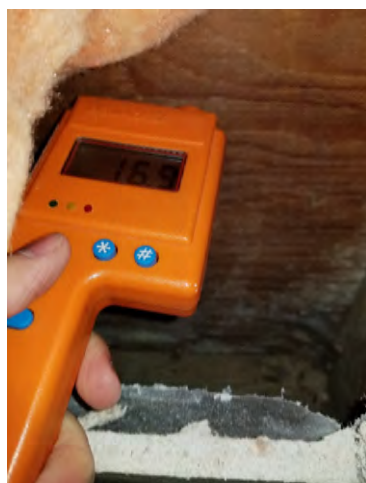
<b>Location:</b>	Rock & Gem Room, south elevation (See Appendix C)	<b>IO 2</b>
<b>Detail:</b>	Cedar cladding, base of wall.	
<b>Moisture Content:</b>	Sheathing: 16.9% / Framing: 10.3%

Assembly	Condition
<ul style="list-style-type: none"> <li>Channel cedar siding</li> <li>Building Paper</li> <li>1/2" plywood</li> <li>2"x6" wood framing at 16" o/c</li> <li>6" batt insulation between studs</li> <li>6 mil polyethylene vapour barrier</li> <li>Interior finishes</li> </ul>	<ul style="list-style-type: none"> <li>Staining and organic growth observed on interior face of sheathing.</li> <li>Fibreglass batt insulation is dirty, indicating air movement across the wall assembly.</li> </ul>
Comments	
<ul style="list-style-type: none"> <li>Fungal air sampling was conducted at this location (see Appendix D, Sample S6).</li> <li>Evidence of moisture related deterioration observed at this location.</li> </ul>

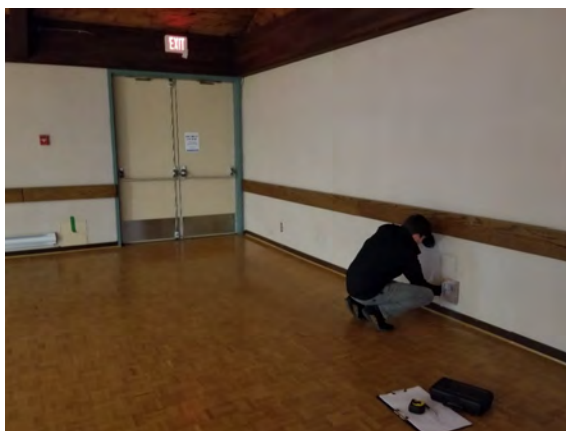
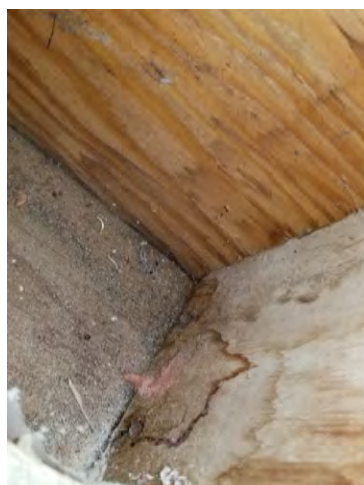
<b>Location:</b>	Ball Room, south elevation (see Appendix C)	<b>IO 3</b>
<b>Detail:</b>	Cedar cladding, base of wall	
<b>Moisture Content:</b>	Sheathing: 10.6% / Framing: 10.5%

Assembly	Condition
<ul style="list-style-type: none"> <li>Channel cedar siding</li> <li>Building Paper</li> <li>1/2" plywood</li> <li>2"x6" wood framing at 16" o/c</li> <li>6" batt insulation between studs</li> <li>6 mil polyethylene vapour barrier</li> <li>Interior finishes</li> </ul>	<ul style="list-style-type: none"> <li>Stained studs, sill plate and sheathing.</li> <li>Fibreglass batt insulation is dirty, indicating air movement across the wall assembly.</li> </ul>
Comments	
<ul style="list-style-type: none"> <li>Evidence of moisture related deterioration observed at this location.</li> </ul>

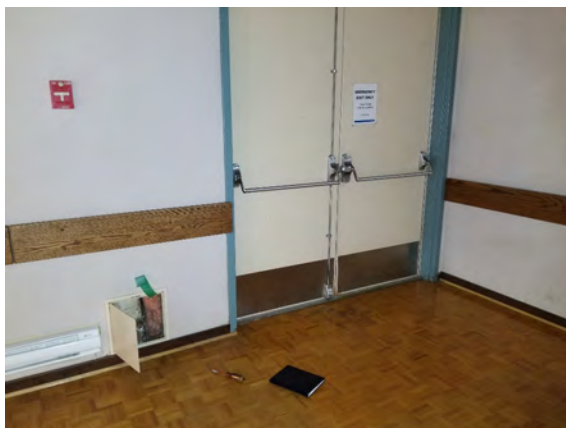
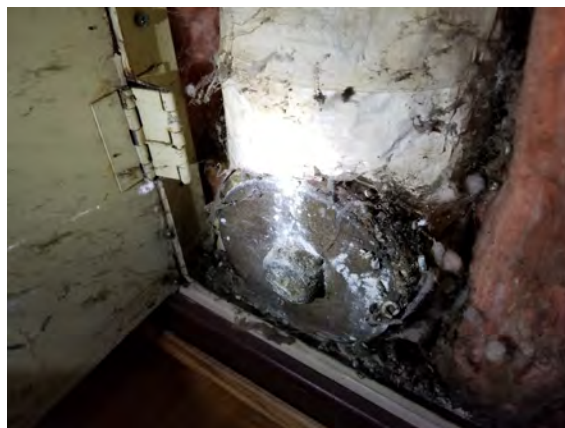
<b>Location:</b>	Ball Room, east elevation (see Appendix C)	<b>IO 4</b>
<b>Detail:</b>	Cedar cladding, base of wall	
<b>Moisture Content:</b>	Sheathing: 9%

Assembly	Condition
<ul style="list-style-type: none"> <li>• Channel cedar siding</li> <li>• Building Paper</li> <li>• 1/2" plywood</li> <li>• 2"x6" wood framing at 16" o/c</li> <li>• 6" batt insulation between studs</li> <li>• 6 mil polyethylene vapour barrier</li> <li>• Interior finishes</li> </ul>	<ul style="list-style-type: none"> <li>• Sheathing not visible at this location.</li> <li>• Fibreglass batt insulation is dirty, indicating air movement across the wall assembly.</li> <li>• Polyethylene vapour barrier is discontinuous across this area.</li> </ul>
Comments	
<ul style="list-style-type: none"> <li>• Exploratory opening was conducted at plumbing cleanout access hatch.</li> <li>• Wall assembly behind access hatch should be cleaned.</li> <li>• Evidence of moisture related deterioration observed at this location.</li> </ul>

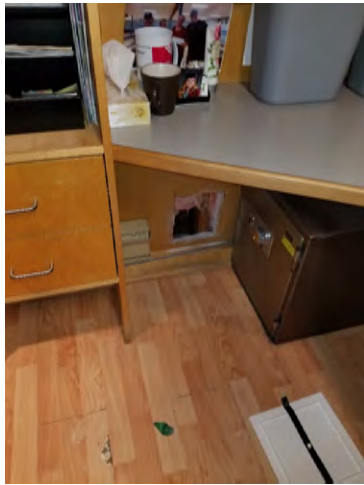
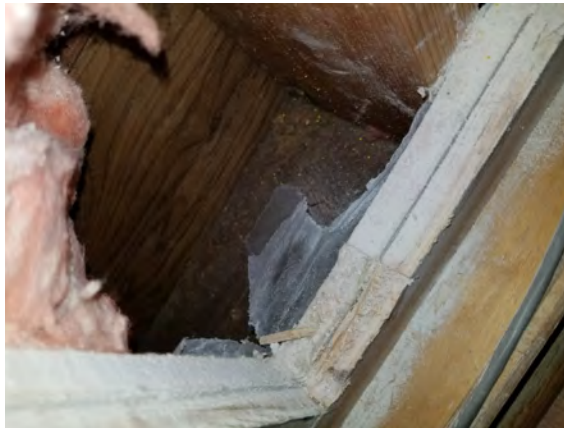
<b>Location:</b>	Front Office, north elevation (see Appendix C)	<b>10 5</b>
<b>Detail:</b>	Cedar cladding, base of wall	
<b>Moisture Content:</b>	Sheathing: 12.8% / Framing 8.6%

Assembly		Condition
<ul style="list-style-type: none"> <li>• Channel cedar siding</li> <li>• Building Paper</li> <li>• 1/2" plywood</li> <li>• 2"x6" wood framing at 16" o/c</li> <li>• 6" batt insulation between studs</li> <li>• 6 mil polyethylene vapour barrier</li> <li>• Interior finishes</li> </ul>		<ul style="list-style-type: none"> <li>• Sheathing was clean and generally good condition at this location.</li> <li>• Fibreglass batt insulation is dirty, indicating air movement across the wall assembly.</li> </ul>
Comments		
<ul style="list-style-type: none"> <li>• No evidence of moisture-related deterioration was observed at this location.</li> <li>• Fungal air sampling was conducted at this location (see Appendix D, Sample S2).</li> </ul>

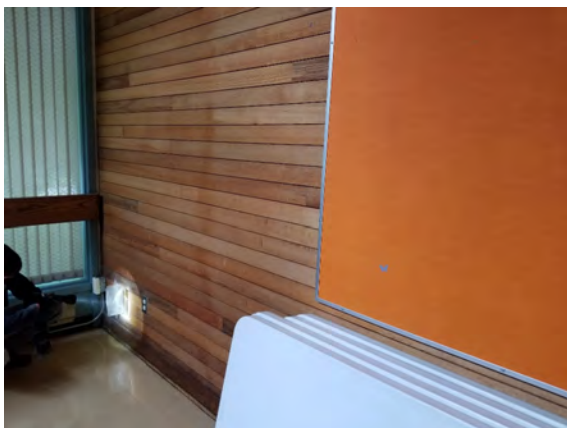
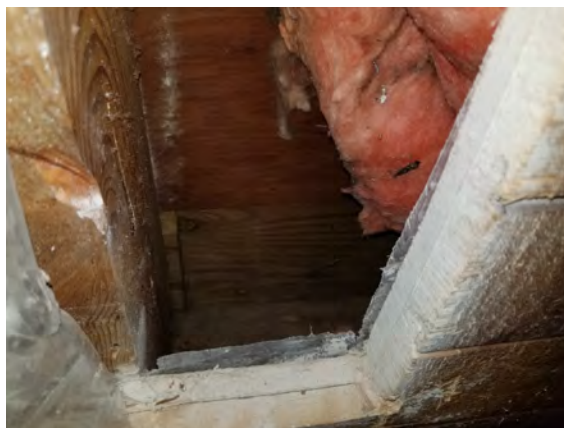
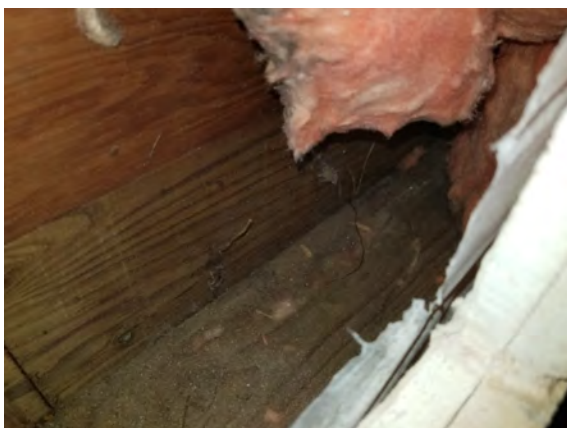
10 6

**Location:** Storage Room, east elevation (see Appendix C)

- Channel cedar siding
- Building Paper
- 1/2" plywood
- 2"x6" wood framing at 16" o/c
- 6" batt insulation between studs
- 6 mil polyethylene vapour barrier
- Interior finishes

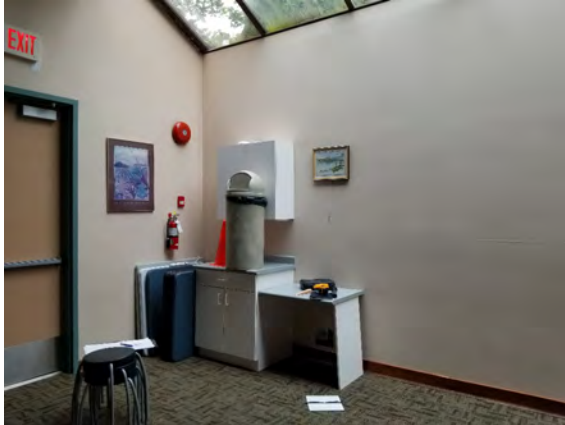
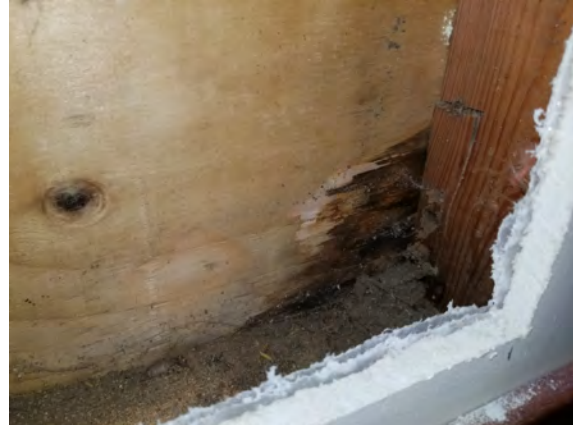
107

Assembly	Condition
<ul style="list-style-type: none"> <li>Channel cedar siding</li> <li>Building Paper</li> <li>1/2" plywood</li> <li>2"x6" wood framing at 16" o/c</li> <li>6" batt insulation between studs</li> <li>6 mil polyethylene vapour barrier</li> <li>Interior finishes</li> </ul>	<ul style="list-style-type: none"> <li>Stained and deteriorated sheathing observed at base of wall.</li> <li>Sheathing was wet at the time of our review.</li> <li>Staining observed on studs at sill plate.</li> <li>Fibreglass batt insulation is dirty, indicating air movement across the wall assembly</li> </ul>
Comments	
<ul style="list-style-type: none"> <li>Evidence of moisture-related deterioration was observed at this location.</li> <li>Fungal air sampling was conducted at this location (see Appendix D, Sample S3).</li> </ul>

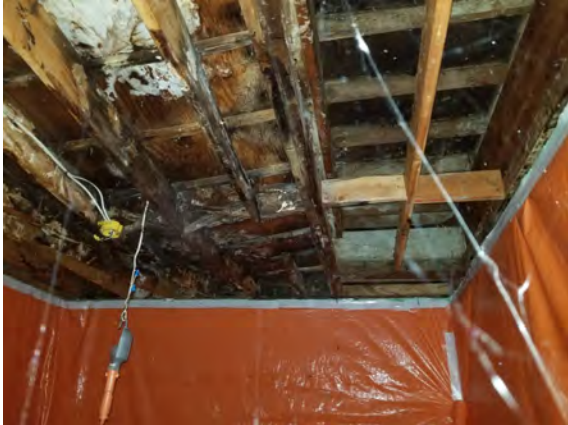
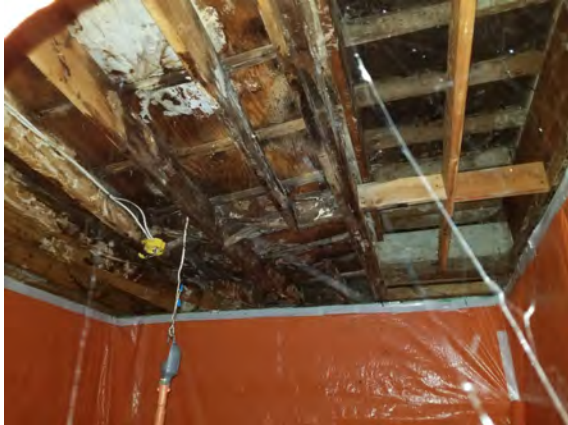
<b>Location:</b> Storage Room, southwest corner of building <b>Detail:</b> Cedar cladding <b>Moisture Content:</b> Could not be measured at this location	<div>IO 8</div>

Assembly	Condition
<ul style="list-style-type: none"> <li>• Channel cedar siding</li> <li>• Building Paper</li> <li>• 1/2" plywood</li> <li>• 2"x6" wood framing at 16" o/c</li> <li>• 6" batt insulation between studs</li> <li>• 6 mil polyethylene vapour barrier</li> <li>• Interior finishes</li> </ul>	<ul style="list-style-type: none"> <li>• Framing is in poor condition due to moisture-related deterioration.</li> <li>• Strong musty smell within the room.</li> <li>• Visible organic growth on exposed framing within the room.</li> </ul>
Comments	
<ul style="list-style-type: none"> <li>• Access to this room has been closed off due to past issues with leaks and deterioration of the wood structure.</li> <li>• Significant evidence of moisture-related deterioration was observed at this location, including organic growth and deterioration of the wood structure.</li> <li>• Fungal air sampling was conducted at this location (see Appendix D, Sample S5).</li> </ul>
