## **BUILDING ENVELOPE CONDITION ASSESSMENT**

### **KYLE CENTER**

125 KYLE STREET  
PORT MOODY, BC

JRS Project No. VR11262A

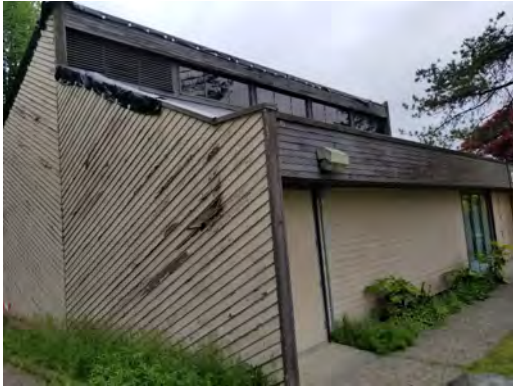
Photo 1

The building is a one storey recreational center with vaulted ceilings, with cedar cladding on all elevations, including wall areas which extend above the roof level (photo 1).

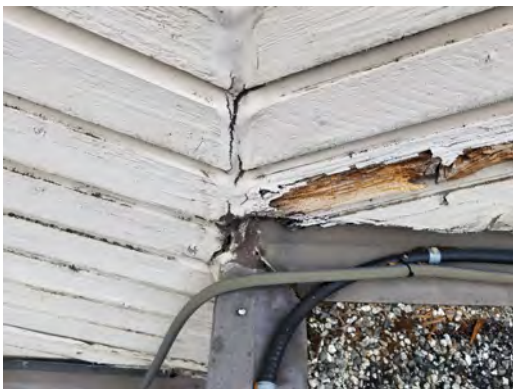
Photo 7

- Wall sealants were found to be in poor condition (photo 7).
- A mechanical rooftop penetration with multiple plies of loose membrane adhered to the cladding was noted (photo 8).

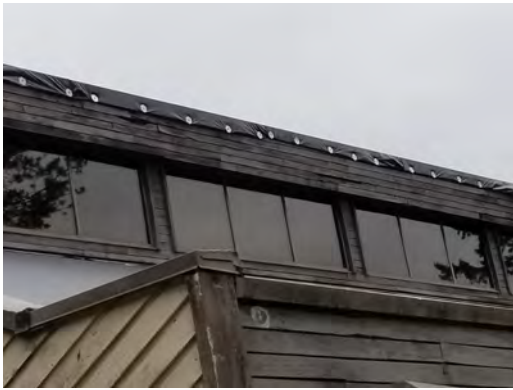
Photo 9

- Several fastener penetrations through the cladding were noted, for the installation of roof tarps as part of emergency repairs (photo 9)
- Exposed building paper was noted behind damaged cladding, much of which was damaged and torn. (photo 10)

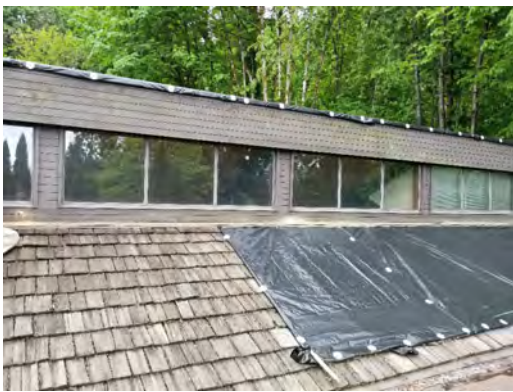
Photo 11

The windows at the building consist of aluminium-framed and steel-framed, double glazed windows. The insulated glazing units (IGUs) include an aluminum spacer bar (photo 11). Some of the steel-framed windows have aluminium operable inserts fastened into the steel frames (photo 12). The IGUs are held in place with removable exterior glazing stops which vary in type and material, depending on the window assembly. In general, all the windows have an interior butyl wet seal, sealing the glass to the frame. At the exterior, the aluminum windows and inserts have a dry rubber gasket sealing the glass to the removable glazing stops. Many of the IGUs are dated 2009, indicating an IGU replacement occurred during or after that year.

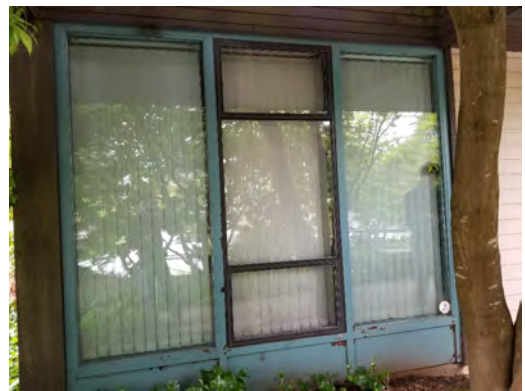
Photo 12

- Failing and flaking paint finish was noted on both the aluminium and steel window frames (photos 12-13).
- Exterior dry rubber gaskets are in poor condition (photo 13). The rubber has dried out and cracked and many of the gaskets have shrunk, providing a location for water to penetrate into the window the assembly.
- Multiple layers of failed sealant were observed around the window perimeters (photo 14).
- Corrosion was observed on aluminium spacer bars within the IGU's indicating IGU failure (photo 15).
- The interior butyl wet seal has compressed out of the joint between the frame and glass, which affects the air seal and weather tightness of the window assembly (photo 16).
- Visible moisture droplets and fogging was observed within several IGUs, indicating failure of the IGUs (photo 17).
- Visible moisture staining on interior sills was noted (photo 18).

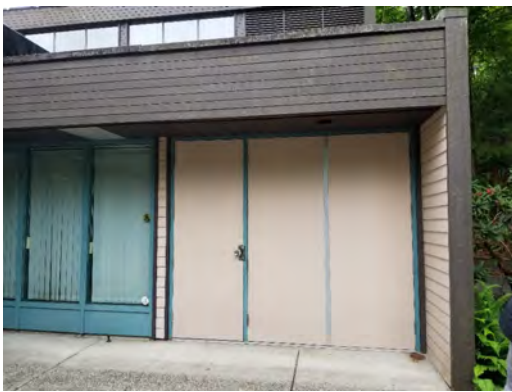
Photo 19

All of the exterior doors on the building are steel swing doors (photo 19) installed into pressed-steel frames. The front doors have glass inserts set into the door leafs. All doors are located under overhang protection (ranging between 3 ft to 8 ft) except for the basement door, which has no overhang protection.

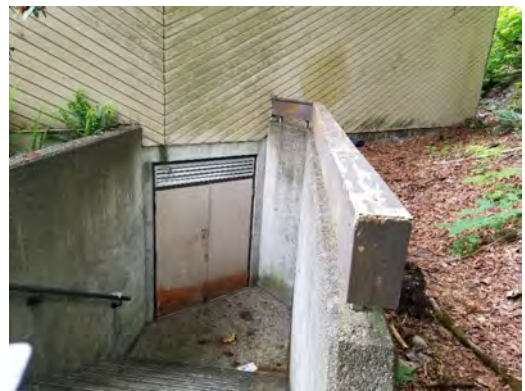
Photo 20

- The lower portions of the basement doors (roughly 1 foot high) are corroded (photo 20)
- Minor paint flaking and surface corrosion were observed on the steel frame doors (photo 21)

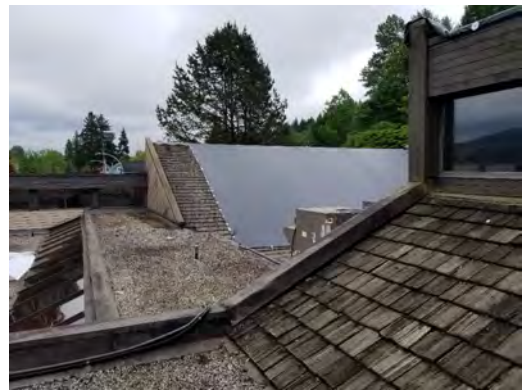
Photo 22

There are two types of low slope roofs on the building: Multi-ply Built-Up-Roof (BUR) and 2-ply SBS roof (photos 22 and 23). Architectural drawings indicate that the low slope roof assembly consists of the following (exterior to interior):

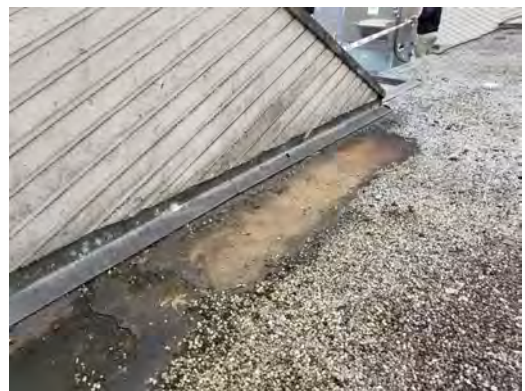
Photo 24

- Gravel protection for the underlying BUR asphalt was noted to be missing and exposing the underlaying assembly in several areas (photo 24).
- Deterioration of the built-up roof assembly was observed across all the BUR roof areas, including drying and shrinking of exposed asphalt (alligatoring, photo 25), blistering, and asphalt blueberries (photo 26).

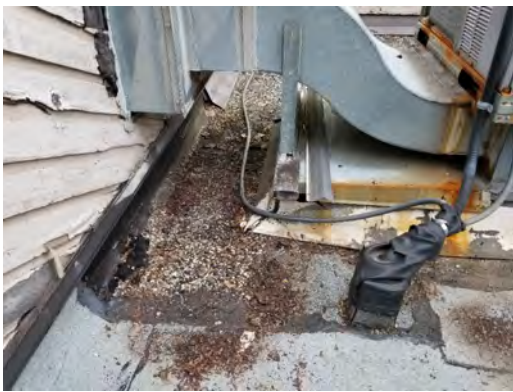
Photo 27

- At-risk roof membrane interface detailing was noted at mechanical rooftop penetrations, access hatches, wall upturns and at interface details with adjacent roof assemblies (photo 27).

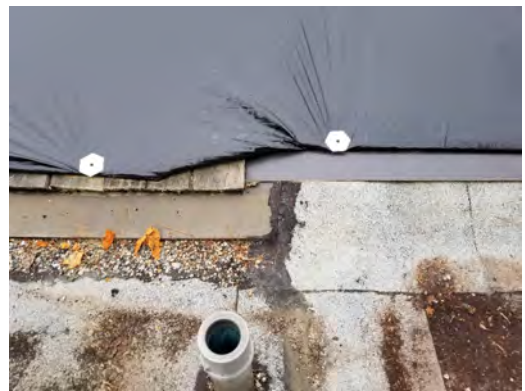
Photo 28

- A large area of the low-slope roof has been replaced with a 2-ply SBS-modified bitumen membrane assembly. The new roof assembly has simply been lapped onto the original BUR in some areas, which continues to serve as an at-risk tie-in within the existing roof systems (photo 28).

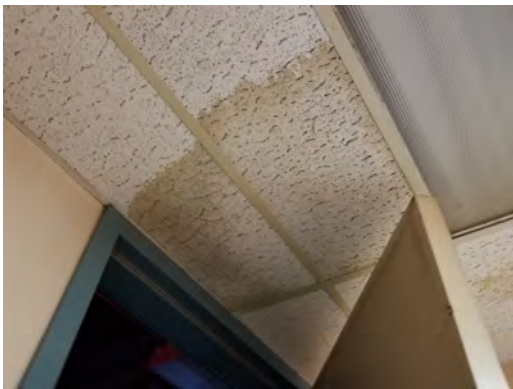
Photo 29

- Water was observed between plies of the SBS-modified bitumen roof membrane at exploratory opening 2 (appendix B).
- Significant staining was observed on several ceiling areas beneath the low slope roofs (photo 29).

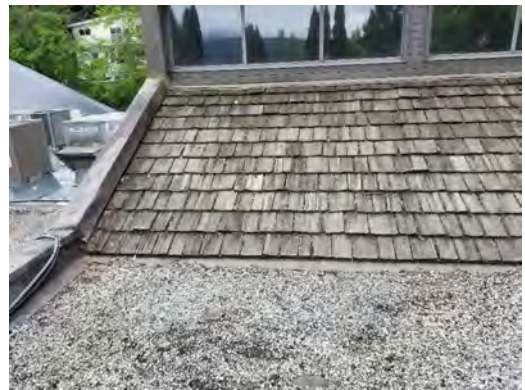
Photo 30

There are several sloped roof areas on all elevations of the complex (photo 30). Architectural drawings indicate that the sloped roof assembly consists of the following:

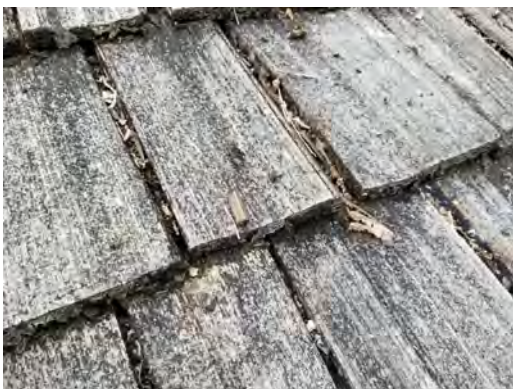
Photo 31

- Damaged and split shingles were observed throughout. In general, the cedar shakes are in poor condition (photo 31).
- Evidence of past, incompatible repairs were observed throughout, including asphalt shingles, sheet metal patches, etc. (photo 32).
- Large areas of the sloped roofs have been tarped over to address recurring leaks (photo 33).
- Fastener penetrations for the tarps were observed throughout the sloped roof assemblies (photo 34).
- Significant staining and water damage was observed beneath the roof decks for the sloped roof areas (photos 35-36).

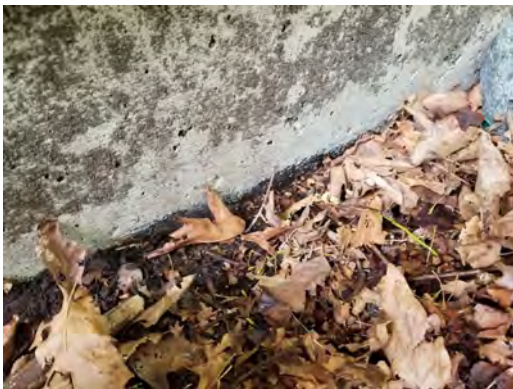
Photo 37

- Evidence of damp-proofing was observed on the foundation walls at grade level (photo 37).
- Localized efflorescence and staining was observed on the north elevation wall, primarily at the concrete cold-joint between the slab and below-grade wall (photo 38).
- Extensive corrosion was observed on the frame and exterior face of the entry door to the basement. This may be due to past issues of standing water or snow at the bottom of the stairwell (photo 39).

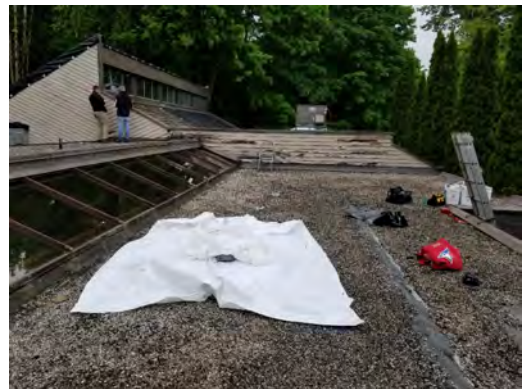
Photo 40

There are two areas of sloped skylights (sloped south to north). One is located between roofs C and A (drains onto roof A, photo 40) and the other is located north of roof H and drains into an eavestrough on the side of the building (photo 41).

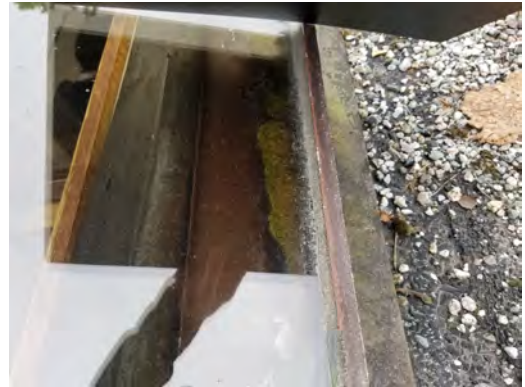
Photo 42

- The skylights were found to be aluminium framed 'T-bar' type construction.
- Moss and organic growth on interior condensation tracks was noted (photo 42).
- Glazing beads at the glazing-frame interface were found to be replaced with sealant (photo 43).
- An active leak was noted at the east corner of the skylights at location H (photo 44).

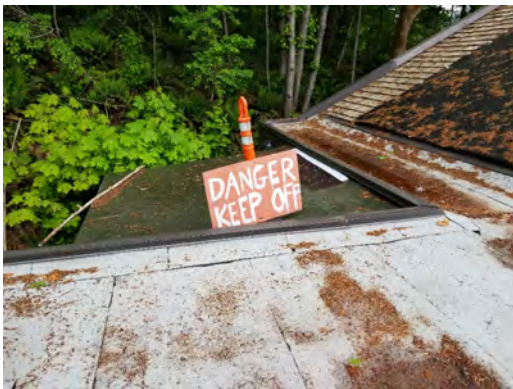
Photo 45

- The storage room is not shown on the architectural drawings (see appendix C).
- The roof framing is in very poor condition, with significant evidence of moisture-related deterioration. It has been tarped over and a “Danger” sign posted on the rooftop (photo 45)
- The roof joists and deck appear to have deflected indicating structural failure (photo 46).
- Increased moisture and humidity levels were recorded within room.

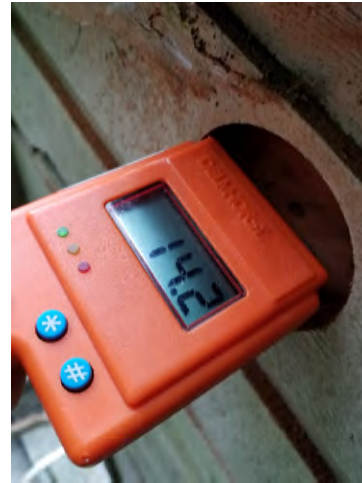
# EO 16

<b>Location:</b>	West elevation, north corner
<b>Detail:</b>	Cedar cladding, below sloped wall at soffit overhang
<b>Moisture Content:</b>	14.2%

Assembly	Condition
<ul style="list-style-type: none"> <li>Channel cedar siding</li> <li>Building Paper</li> <li>1/2" plywood</li> <li>2"x6" wood framing at 16" o/c</li> <li>6" batt insulation between studs</li> <li>6 mil polyethylene vapour barrier</li> <li>Interior finishes</li> </ul>	<ul style="list-style-type: none"> <li>Cladding in poor condition at this location.</li> <li>Building paper was in generally good condition at the time of our review.</li> <li>Sheathing appeared dry at the time of our review.</li> </ul>
Comments	
<ul style="list-style-type: none"> <li>Assembly was dry at the time of our review.</li> </ul>

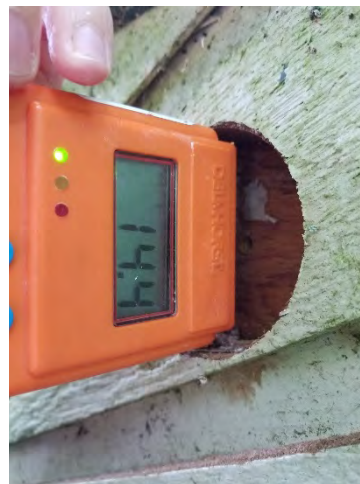
<b>Location:</b>	West-elevation, south corner	<b>EO 17</b>
<b>Detail:</b>	Cedar cladding, below sloped roof area	
<b>Moisture Content:</b>	14.4%

Assembly	Condition
<ul style="list-style-type: none"> <li>Channel cedar siding</li> <li>Building Paper</li> <li>1/2" plywood</li> <li>2"x6" wood framing at 16" o/c</li> <li>6" batt insulation between studs</li> <li>6 mil polyethylene vapour barrier</li> <li>Interior finishes</li> </ul>	<ul style="list-style-type: none"> <li>Cladding in poor condition at this location.</li> <li>Building paper was in generally good condition at the time of our review.</li> <li>Staining visible on sheathing.</li> </ul>
Comments	
<ul style="list-style-type: none"> <li>Evidence of past moisture ingress behind building paper at this location.</li> </ul>

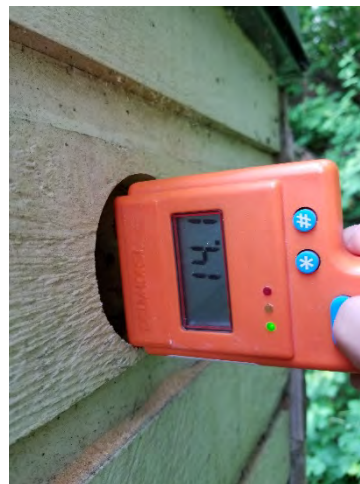
<b>Location:</b>	West-elevation, south corner	<b>EO 18</b>
<b>Detail:</b>	Cedar cladding, below parapet flashing.	
<b>Moisture Content:</b>	14.1%

Assembly	Condition
<ul style="list-style-type: none"> <li>Channel cedar siding</li> <li>Building Paper</li> <li>1/2" plywood</li> <li>2"x6" wood framing at 16" o/c</li> <li>6" batt insulation between studs</li> <li>6 mil polyethylene vapour barrier</li> <li>Interior finishes</li> </ul>	<ul style="list-style-type: none"> <li>Cladding in fair condition at this location.</li> <li>Building paper was in generally good condition at the time of our review.</li> <li>Staining visible on sheathing.</li> </ul>
Comments	
<ul style="list-style-type: none"> <li>Evidence of past moisture ingress behind building paper at this location.</li> </ul>

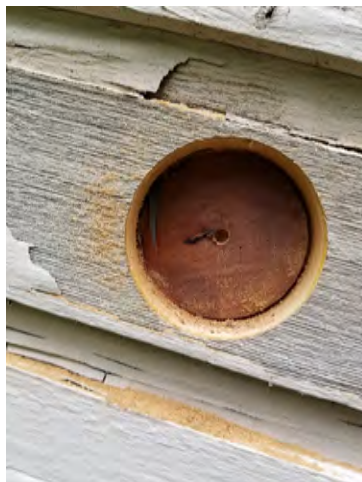
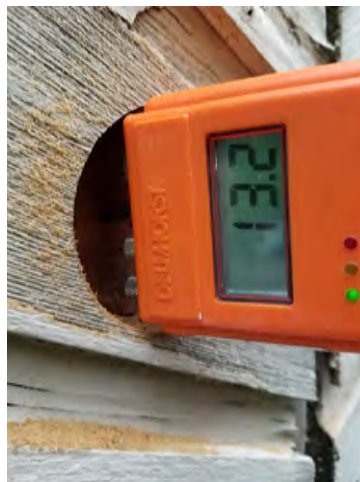
<b>Location:</b>	South-elevation	<b>EO 19</b>
<b>Detail:</b>	Cedar cladding, adjacent to vertical sealant joint	
<b>Moisture Content:</b>	13.2%	
<div>

</div>
Assembly		Condition
<ul style="list-style-type: none"><li>• Channel cedar siding</li><li>• Building Paper</li><li>• 1/2" plywood</li><li>• 2"x6" wood framing at 16" o/c</li><li>• 6" batt insulation between studs</li><li>• 6 mil polyethylene vapour barrier</li><li>• Interior finishes</li></ul>		<ul style="list-style-type: none"><li>• Cladding in poor condition at this location.</li><li>• Building paper was in generally fair condition at the time of our review.</li><li>• Sheathing appeared dry at the time of our review.</li></ul>
Comments		
<ul style="list-style-type: none"><li>• Assembly was dry at the time of our review.</li></ul>

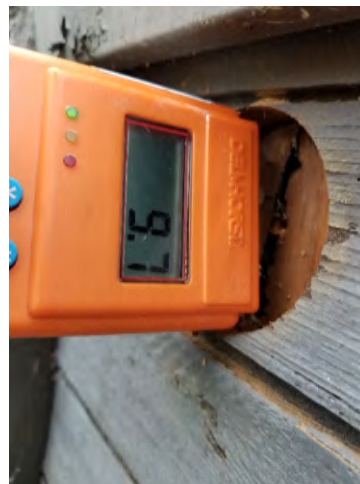
**EO 20**

**Location:** East-elevation, south corner  
**Detail:** Cedar cladding, below parapet flashing  
**Moisture Content:** 9.7%

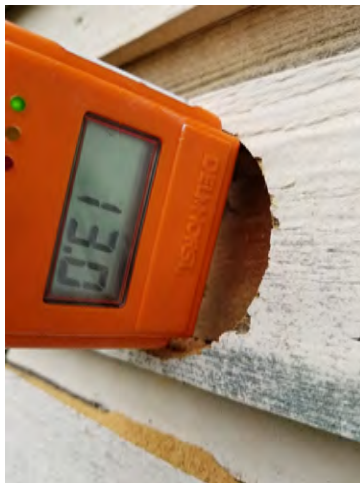
EO 21

<b>Location:</b>	East-elevation, north corner
<b>Detail:</b>	Cedar cladding, below roof parapet flashing
<b>Moisture Content:</b>	13.0%

Assembly	Condition
<ul style="list-style-type: none"> <li>Channel cedar siding</li> <li>Building Paper</li> <li>1/2" plywood</li> <li>2"x6" wood framing at 16" o/c</li> <li>6" batt insulation between studs</li> <li>6 mil polyethylene vapour barrier</li> <li>Interior finishes</li> </ul>	<ul style="list-style-type: none"> <li>Cladding in poor condition at this location.</li> <li>Building paper was in generally fair condition at the time of our review.</li> <li>Sheathing appeared dry at the time of our review.</li> </ul>
Comments	
<ul style="list-style-type: none"> <li>Assembly was dry at the time of our review.</li> </ul>

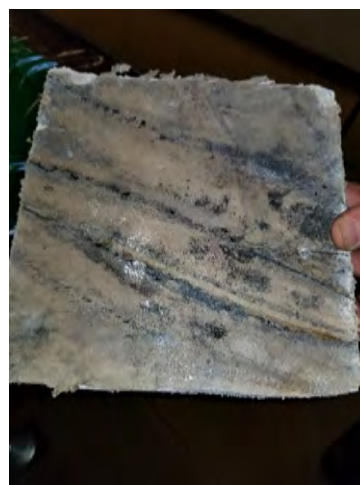
IO 1

**Moisture Content:** Sheathing: 14.3% / Framing: 10.1%

- Organic growth observed on backside of interior gypsum finish.
- Fungal air sampling was conducted at this location (see Appendix D, Sample S4).
- Evidence of moisture related deterioration observed at this location.

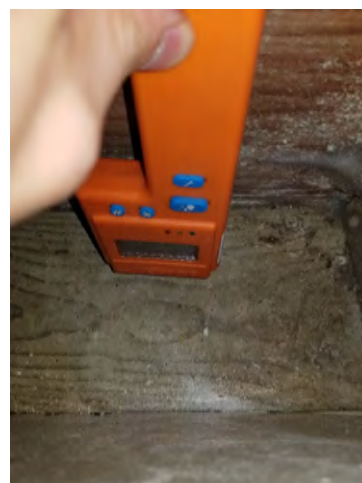
<b>Location:</b>	Rock & Gem Room, south elevation (See Appendix C)	<b>IO 2</b>
<b>Detail:</b>	Cedar cladding, base of wall.	
<b>Moisture Content:</b>	Sheathing: 16.9% / Framing: 10.3%

Assembly	Condition
<ul style="list-style-type: none"> <li>Channel cedar siding</li> <li>Building Paper</li> <li>1/2" plywood</li> <li>2"x6" wood framing at 16" o/c</li> <li>6" batt insulation between studs</li> <li>6 mil polyethylene vapour barrier</li> <li>Interior finishes</li> </ul>	<ul style="list-style-type: none"> <li>Staining and organic growth observed on interior face of sheathing.</li> <li>Fibreglass batt insulation is dirty, indicating air movement across the wall assembly.</li> </ul>
Comments	
<ul style="list-style-type: none"> <li>Fungal air sampling was conducted at this location (see Appendix D, Sample S6).</li> <li>Evidence of moisture related deterioration observed at this location.</li> </ul>

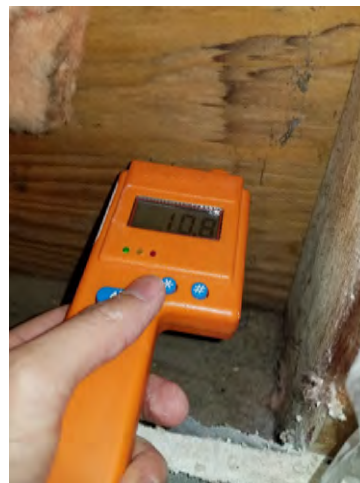
<b>Location:</b>	Ball Room, south elevation (see Appendix C)	<b>IO 3</b>
<b>Detail:</b>	Cedar cladding, base of wall	
<b>Moisture Content:</b>	Sheathing: 10.6% / Framing: 10.5%

Assembly	Condition
<ul style="list-style-type: none"> <li>Channel cedar siding</li> <li>Building Paper</li> <li>1/2" plywood</li> <li>2"x6" wood framing at 16" o/c</li> <li>6" batt insulation between studs</li> <li>6 mil polyethylene vapour barrier</li> <li>Interior finishes</li> </ul>	<ul style="list-style-type: none"> <li>Stained studs, sill plate and sheathing.</li> <li>Fibreglass batt insulation is dirty, indicating air movement across the wall assembly.</li> </ul>
Comments	
<ul style="list-style-type: none"> <li>Evidence of moisture related deterioration observed at this location.</li> </ul>
